## PROJECT EXAMPLE

# Langbank Project

**J.Shearer were asked to carry out an initial site survey of this sandstone detached property as the client was experiencing several areas of water ingress.**

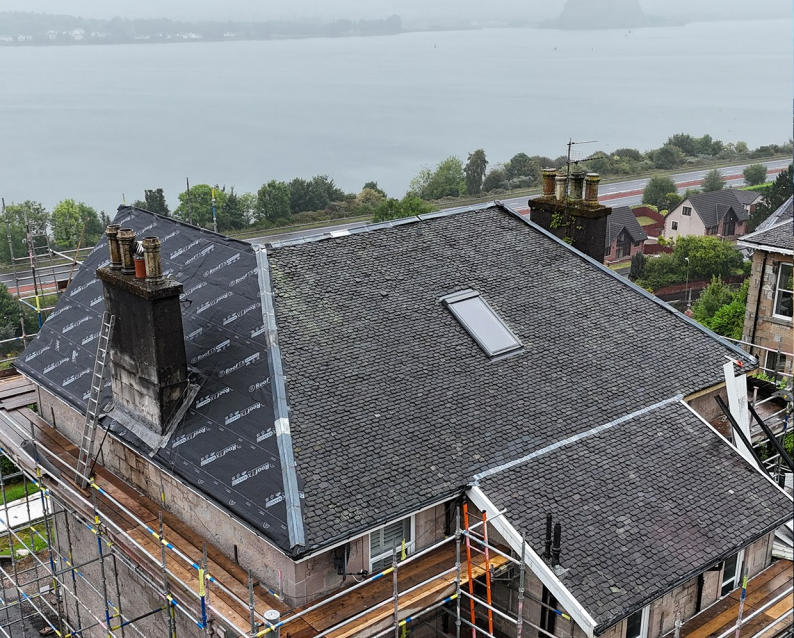
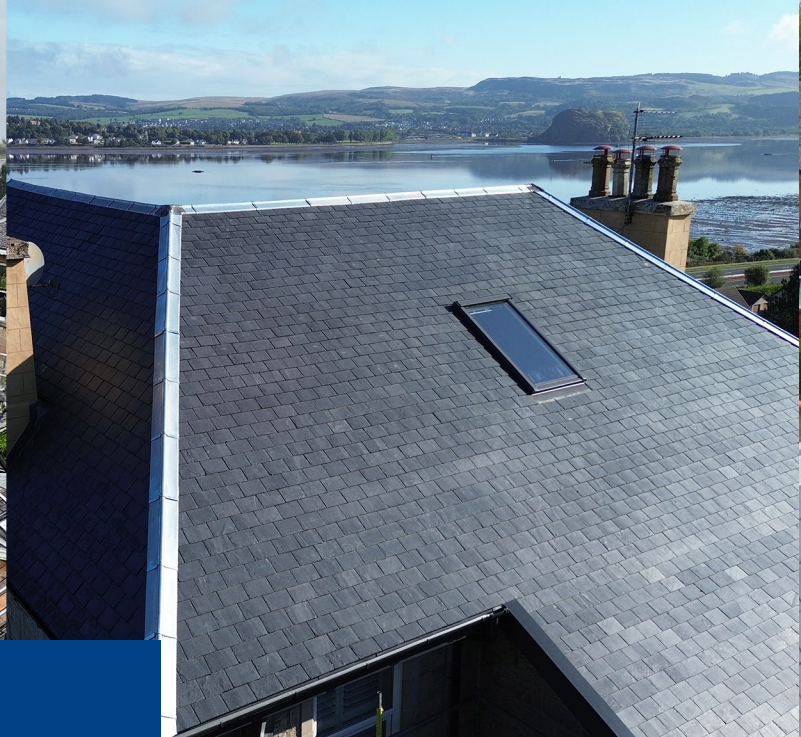
Upon inspection we found that the existing slate roof covering was in poor condition and unfortunately was beyond repair. This property is very exposed to severe weather therefore we recommended to re slate this property using Cupa Heavy 3 Spanish slate.

- ▶ Strip off existing slate roof coverings and remove from site.
- ▶ Replacement of all lead work.
- ▶ New breathable roofing membrane installed.
- ▶ Replacement Velux window.
- ▶ Re rendering of chimney stacks
- ▶ Replacement uPVC roofline & rainwater goods
- ▶ Re slate using Cupa Heavy 3 Spanish slate
- ▶ Installation of new vented Zinc ridging.
